# Near Shore Lake Sediments in Miller Bay, Lake Osakis in 2021 and Curlyleaf Pondweed Delineations in 2021 and 2022

*Prepared by Steve McComas, Blue Water Science*

**January 23, 2023**

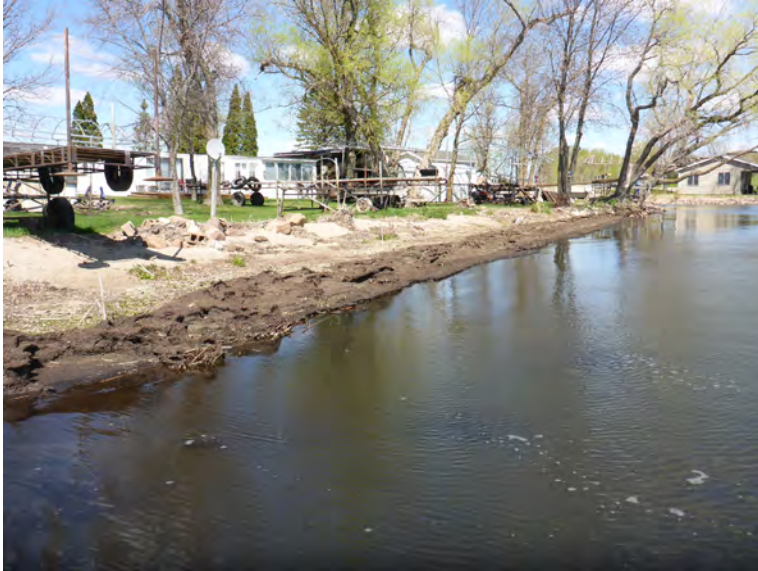
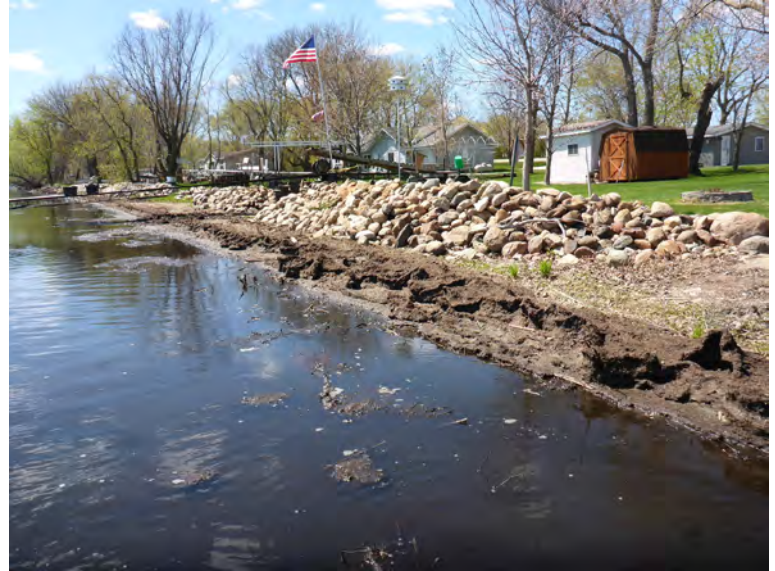
**Figure 2. On May 7, 2021 material along the shoreline is mostly finely-shredded vegetative material. Examination under the microscope indicates there was very little terrestrial material, it appeared to be nearly all aquatic in origin. It was estimated to consist of about 555 cubic yards. The material was most likely blown in from the main lake basin.**

**[Organic matter estimate: 1,000 feet of shoreline with 15 feet band of soft sediment about 1 foot thick = 15,000 cubic feet = 555 cubic yards = about 100 dump truck loads (assuming 6 cubic yards per truck load)]**

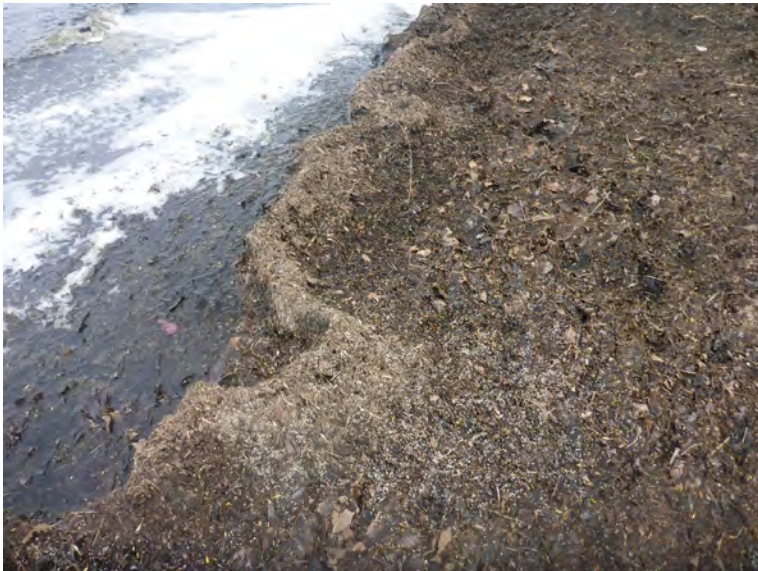
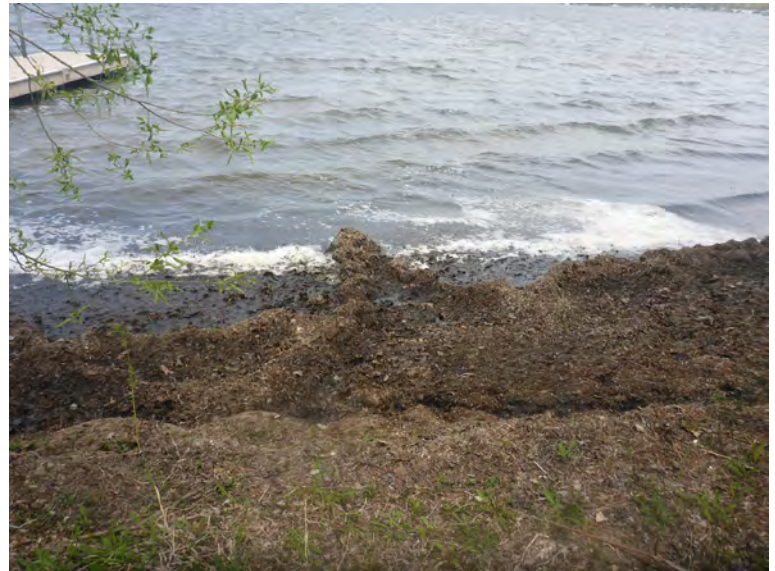
**Figure 3. French Lake was visited on May 3, 2021. It had organic matter accumulation on the shoreline similar to what was observed in Miller Bay in Lake Osakis. The French Lake material was blown into the nearshore area and concentrated by wave action.**
